# FACILITY COMPLIANCE INSPECTION REPORT

## Division of Waste Management Solid Waste Section

**Date of Site Inspection:** November 3, 2011 **Date of Last Inspection:** February 12, 2009

Northfield Farms LCID Landfill  
 306 W. Old Glencoe Road  
 Burlington, NC 27217

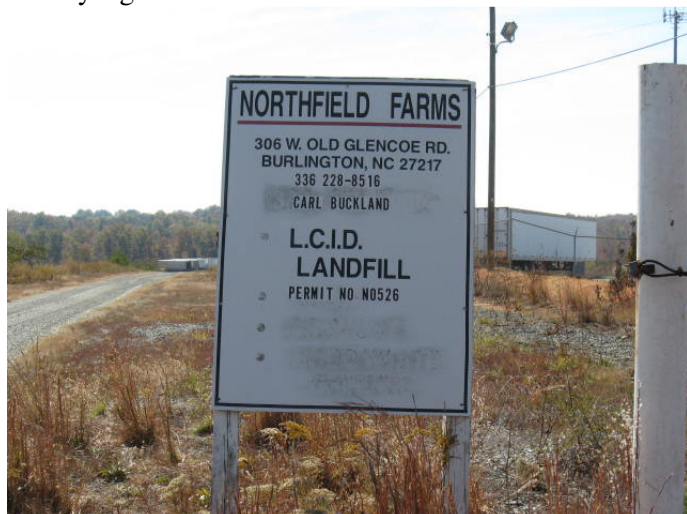
Facility sign

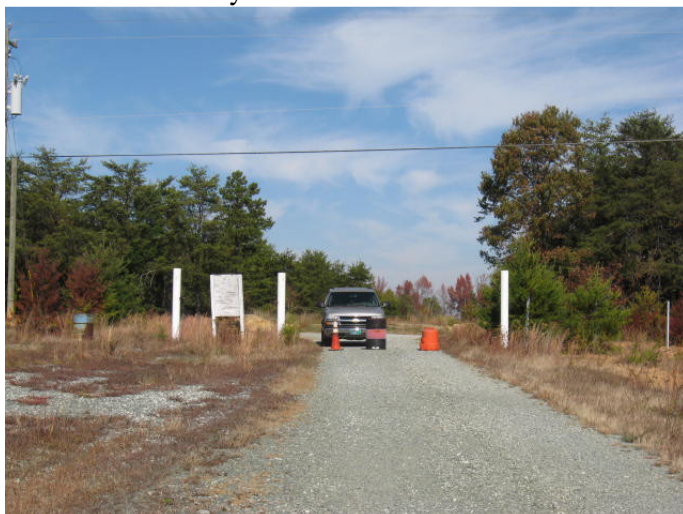
Entrance to facility

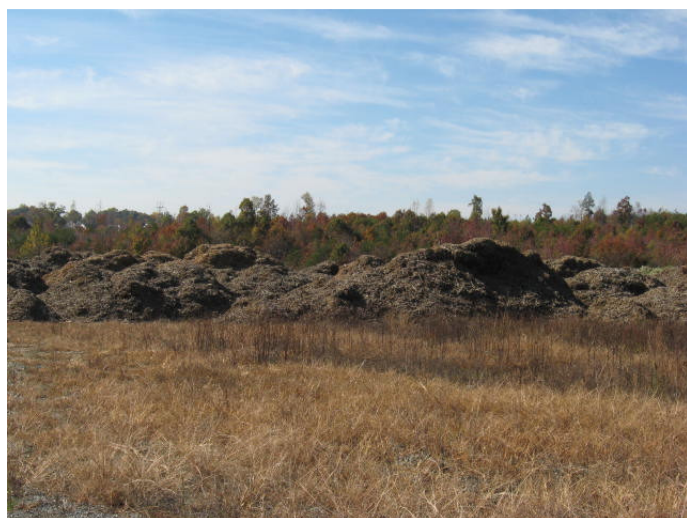
3. There is a mound of material overgrown with weeds in the center of the landfill area. Mr. Buckland stated that it is a stockpile of soil.
4. Several piles of mulch are stored on the landfill area. Mr. Buckland stated that the mulch is ground off-site and brought to the facility for re-sale.

Stored mulch atop LCID landfill area

5. Ensure that wood grinding does not occur at the facility unless a Land Clearing Debris Treatment and Processing Facility Notification form is obtained from the SWS prior to operation.

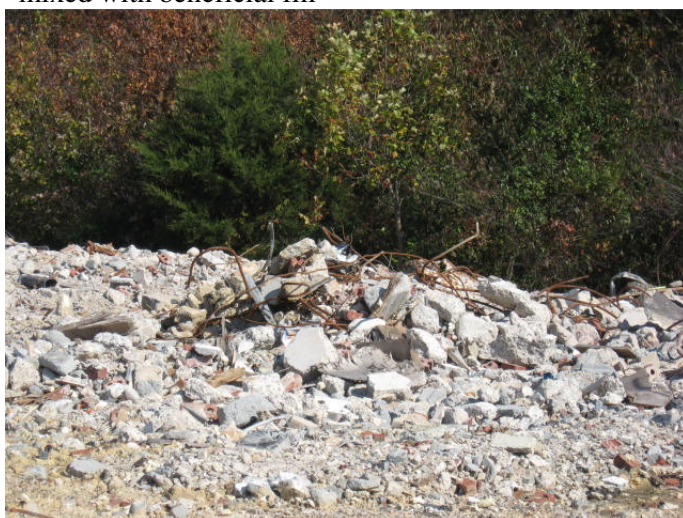
Representative picture of non-conforming material mixed with beneficial fill

11. Ensure that beneficial fill material consists only of inert debris (concrete, brick, uncontaminated soil, stone, and used asphalt). All fill material must not be painted. Rebar must be cut flush with concrete.

12. Ensure that beneficial fill material does not contain rebar, wood, and plastic. Remove all non-conforming material from beneficial fill.
13. The facility is secured by a locked steel cable at the entrance to the property.
